INDOOR AIR QUALITY REASSESSMENT

**Housatonic Grammar School
Berkshire Hills Regional School District
Pleasant Street
Housatonic, Great Barrington, Massachusetts**

Prepared by:
Massachusetts Department of Public Health
Bureau of Environmental Health Assessment
August 2002

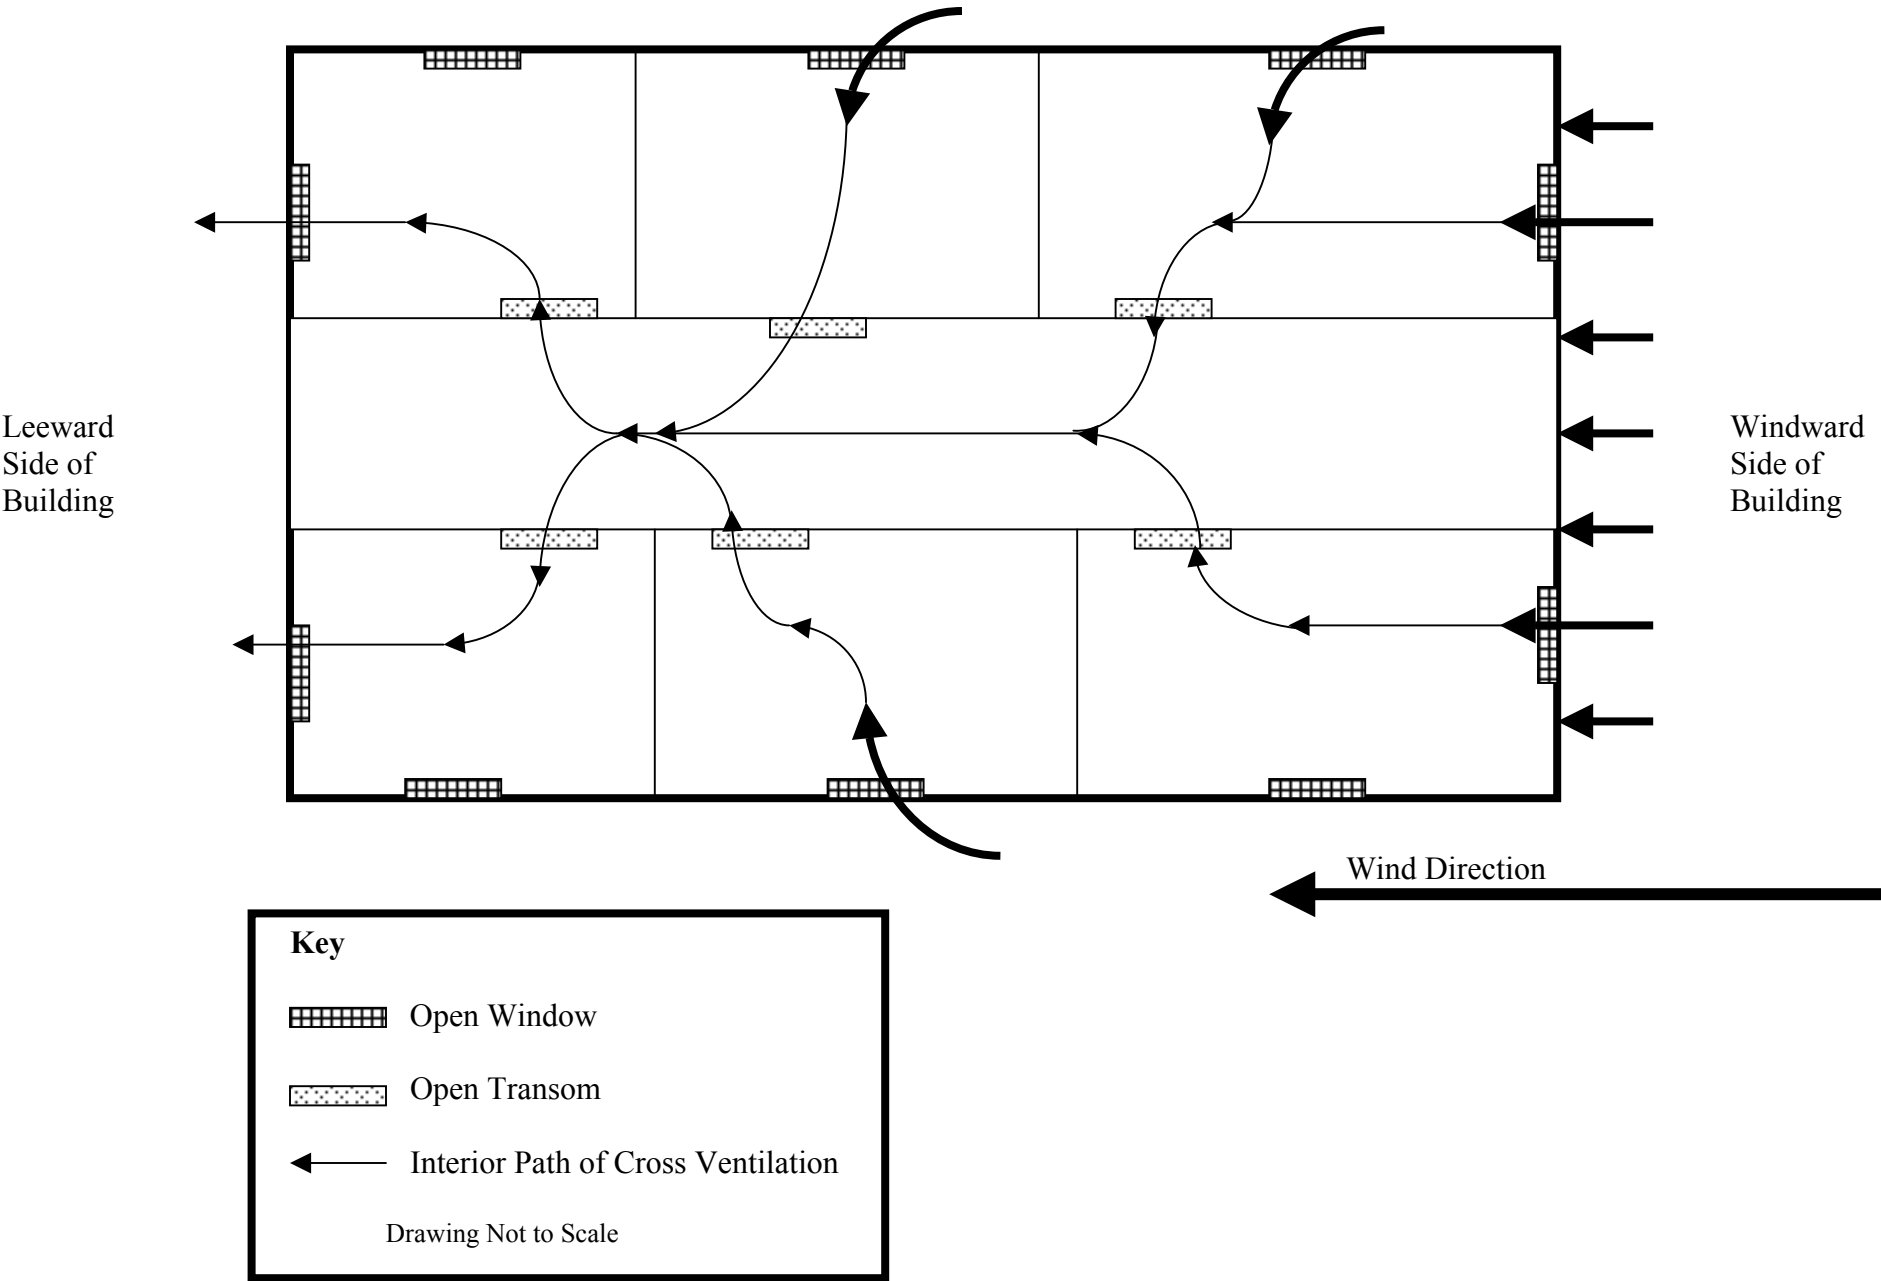
Figure 2

During the summer months, ventilation is reportedly supplemented by the use of openable windows in classrooms. The building was designed to use cross-ventilation to provide comfort for building occupants. It is equipped with windows on opposing exterior walls. In addition, the building has hinged windows located above the hallway doors. This hinged window (called a transom) enables the classroom occupant to close the hallway door while maintaining a pathway for airflow. This design allows for airflow to enter an open window, pass through a classroom, pass through the open transom, enter the hallway, pass through the opposing open classroom transom, into the opposing classroom and exit the

building on the leeward side (opposite the windward side) (see Figure 2). With all windows and transoms open, airflow can be maintained in a building regardless of the direction of the wind. This system fails if the windows or transoms are closed (see Figure 3). Each classroom would have a long pole with a hook that was used to open the hoop latch that locks the transom closed. Most transoms in the 1919 building were closed during the assessment, which can inhibit airflow in the summer.

Cross Ventilation in a Building Using Open Windows and Transoms

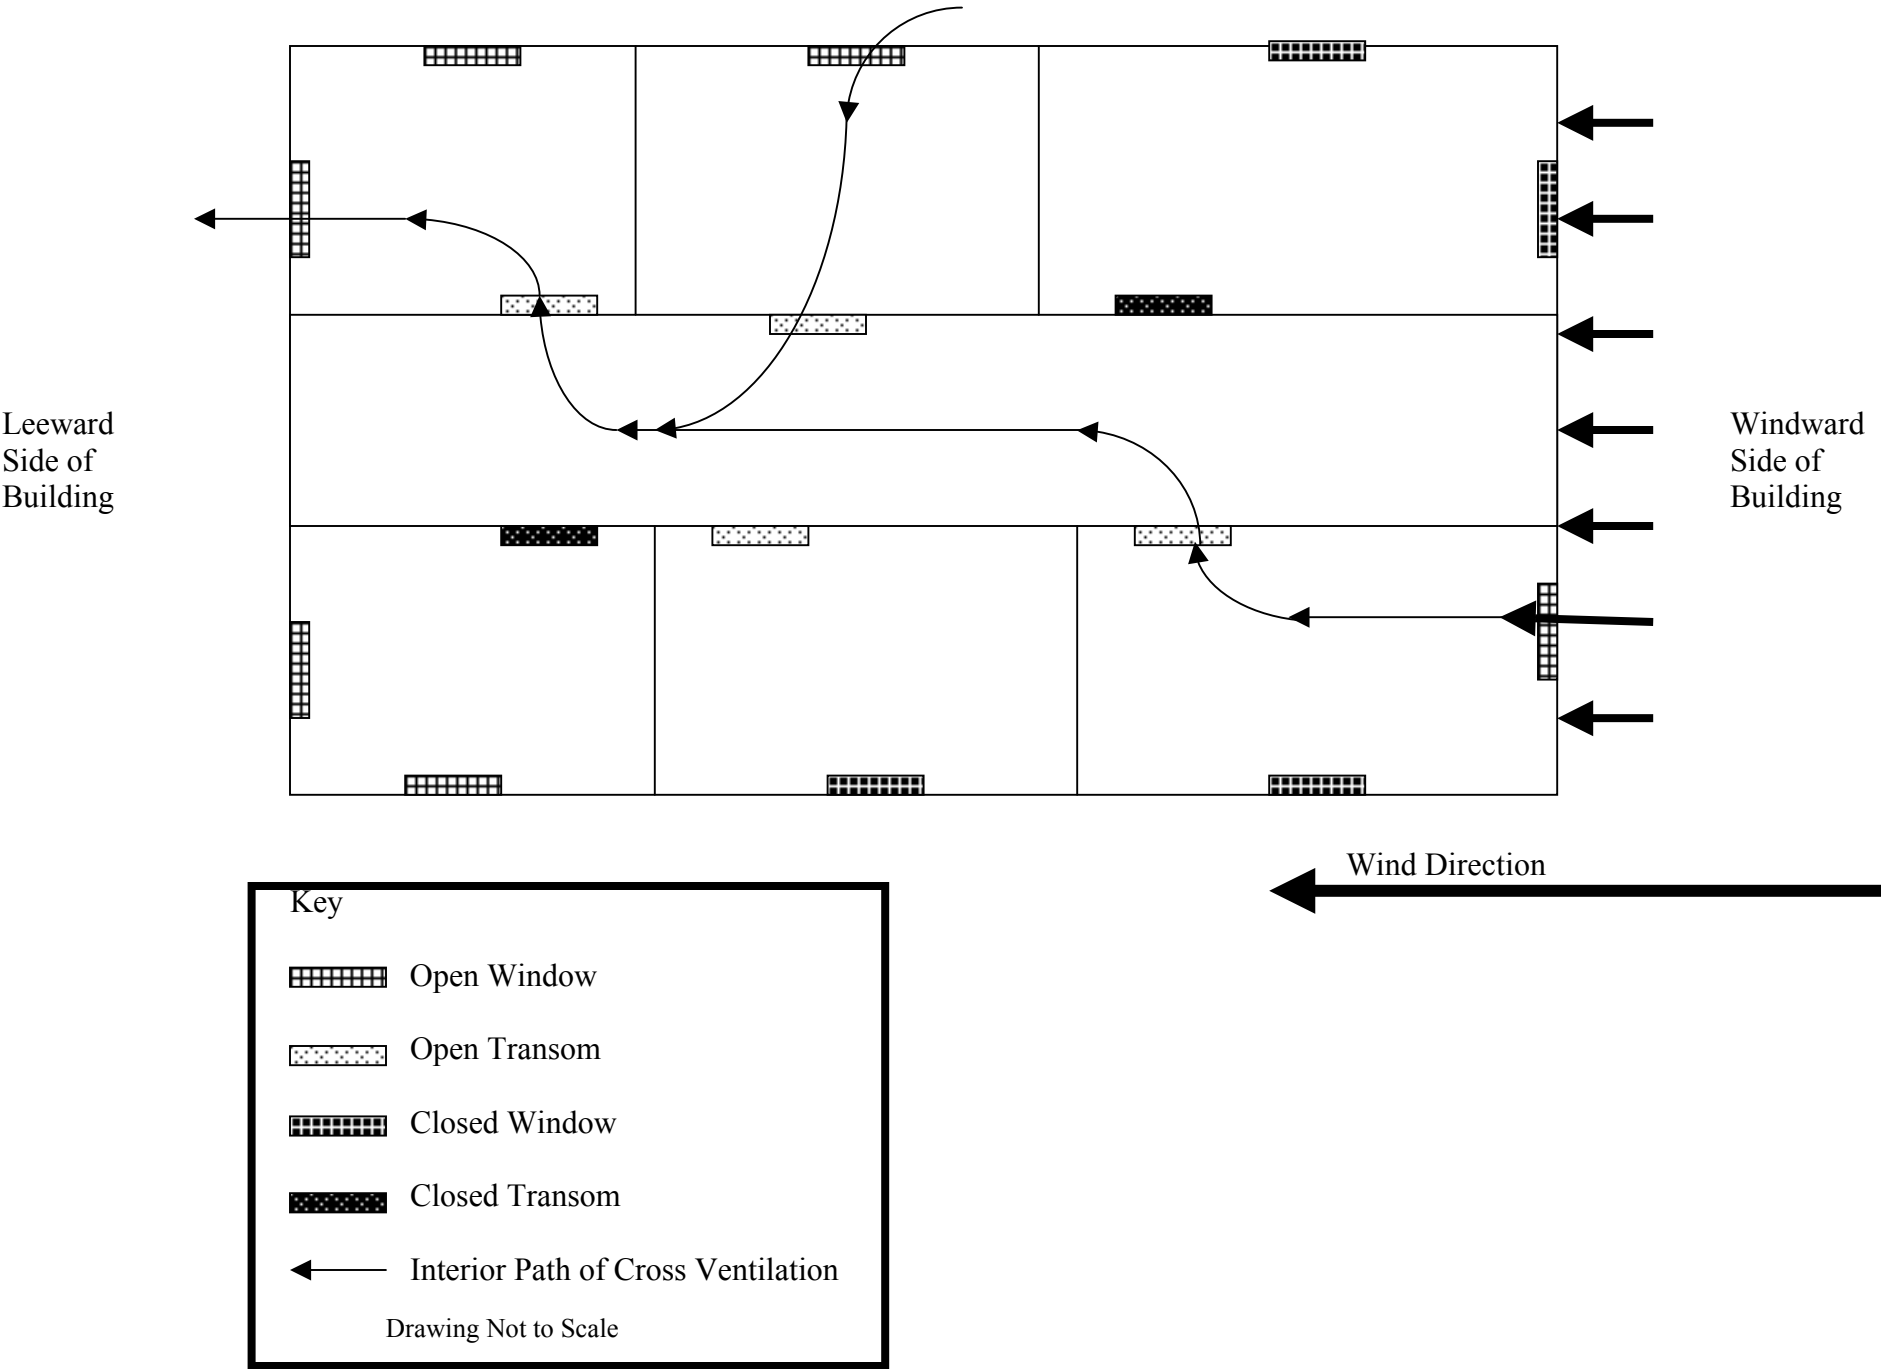
Figure 3

Inhibition of Cross Ventilation in a Building with Several Windows and Transoms Closed

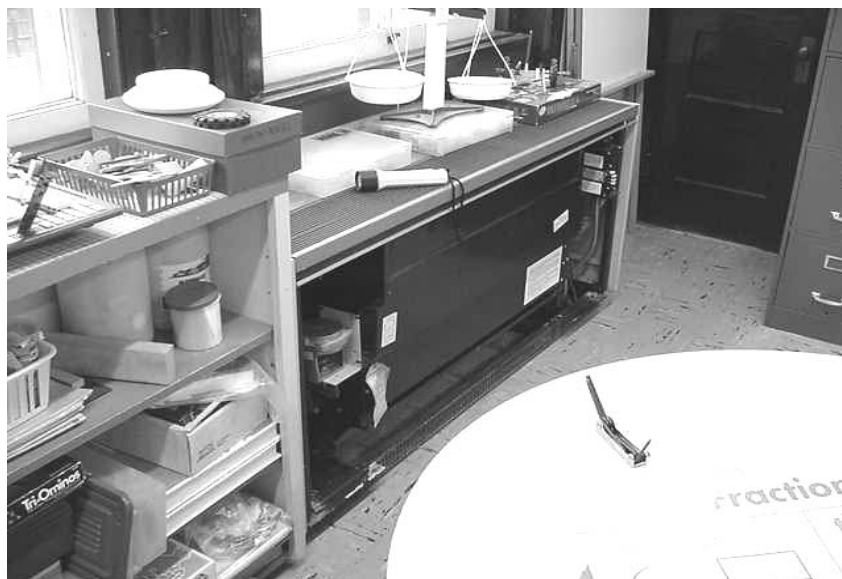
Picture 1

Fresh air in classrooms throughout the building is provided by unit ventilators (univents) (see [Figure 1](#), Picture 1). Univents draw air from outdoors through a fresh air intake located on the exterior walls of the building and return air through an air intake located at the base of each unit. The mixture of fresh and return air is drawn through a filter and heating coil and is then provided to the classroom from the univent by motorized fans through a fresh air diffuser on the top of the unit. Univents were obstructed and/or deactivated in a number of areas. To function as designed, univent diffusers and returns must remain free of obstructions. Importantly, these units must be activated and allowed to operate.

Typical Univent (front Cover Removed)

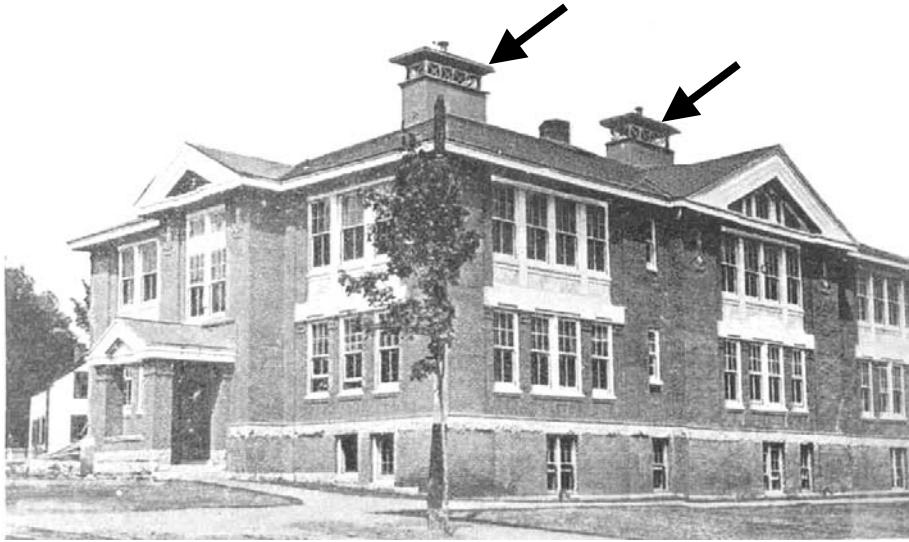
Picture 2

Picture of HES Prior to Ventilation System Renovation, Note Ventilation Shaft Termini on Roof
(Date of picture and photographer unknown, picture is a copy from school flyer)

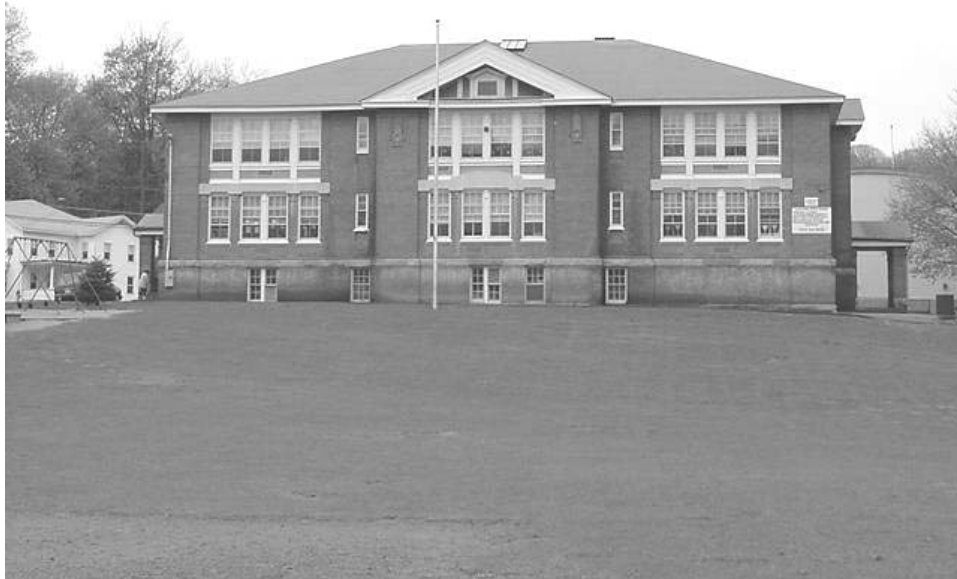
Picture 3

Current Configuration of Roof

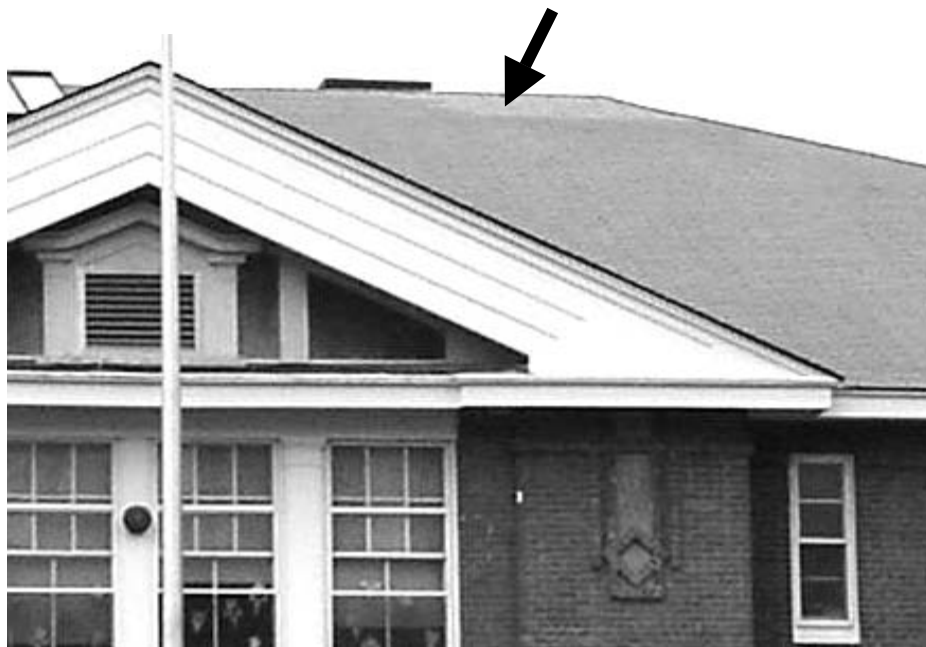
Picture 4

Former Location of North Air Shaft, Note Roof Shingle Color

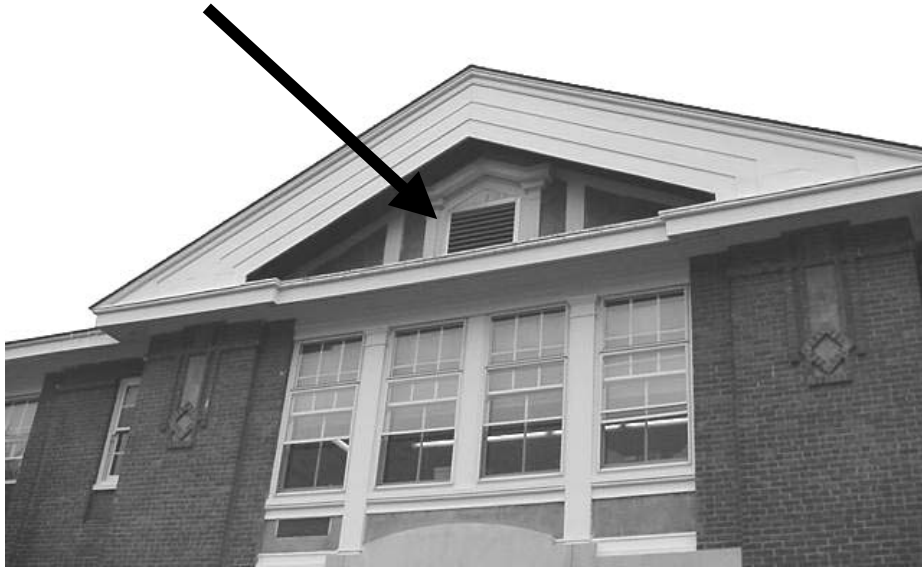
Picture 5

Gable Installed Exhaust Vent, West wall of HES

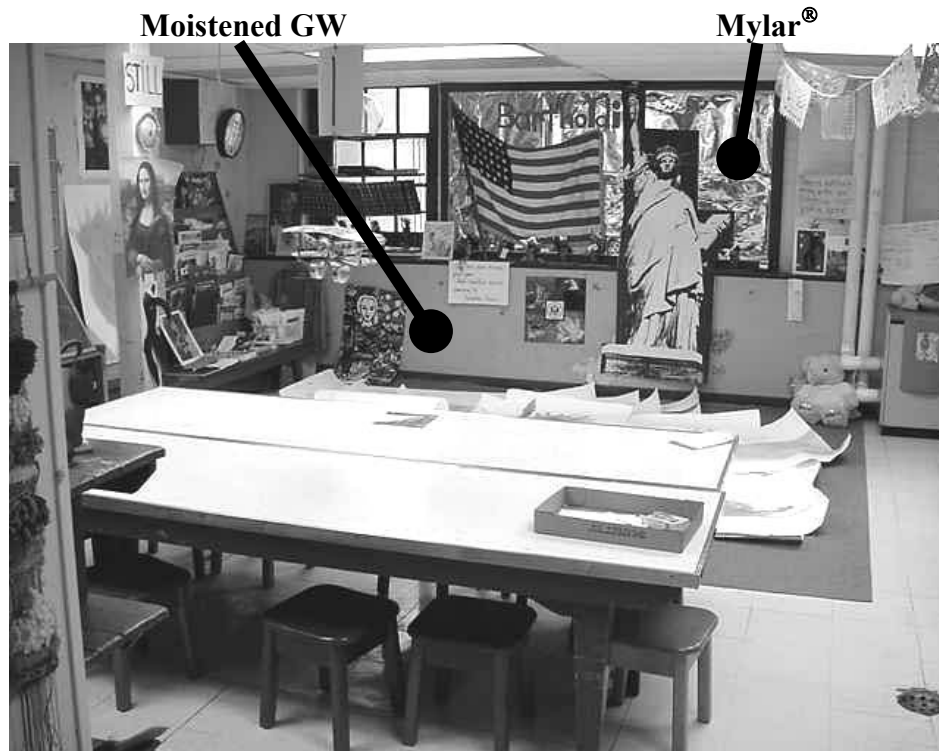
Picture 6

Building occupants reported that visible mold growth had occurred in interior wall materials covering foundation walls in the basement, particularly a section of wall covered with Mylar[®] (see Picture 6). Mylar[®] is a plastic material that is water impermeable. If the underlying wall materials were to become moistened, the Mylar[®] would prevent water evaporation, which may result in the production of microbial growth.

The exterior wall along the foundation in the art room had GW with moisture content measurements over ≥ 0.6 percent, which suggests dampening by a water source. Please note that moisture content of GW measured is a real time measurement of the conditions present in the building on May 2, 2002. Moisture content may increase or decrease dependent on building and weather conditions.

Moisture sources in the indoor environment can originate from several sources. One possible source of moisture in GW may be classroom univents. This does not appear likely since GW is not located near the fresh air supply for the art room univent. GW near univents had moisture content readings within the normal range. The absence of water damaged plaster as well as decreased moisture content in GW in hallway and adjoining walls appears to eliminate moisture sources from plumbing or HVAC system chilled-water pipes. With the location of increased moisture content along the foundation wall, water penetration from rain through the curtain wall/drainage plane and/or inadequate rainwater drainage appear to be the most likely sources.

Moistened GW wallboard in Art Room

3. Seal wall and pipe floor holes within univent casing.
4. Remove water damaged GW from art room. Recommendations concerning this operation are included under the subsection **Renovations** on page 17.

12. Dispose of contaminated materials in a manner to prevent cross contamination in other sections of the building (US EPA, 2001).
13. Once GW is removed, determine the source of moisture and remediate prior to installation of new GW.

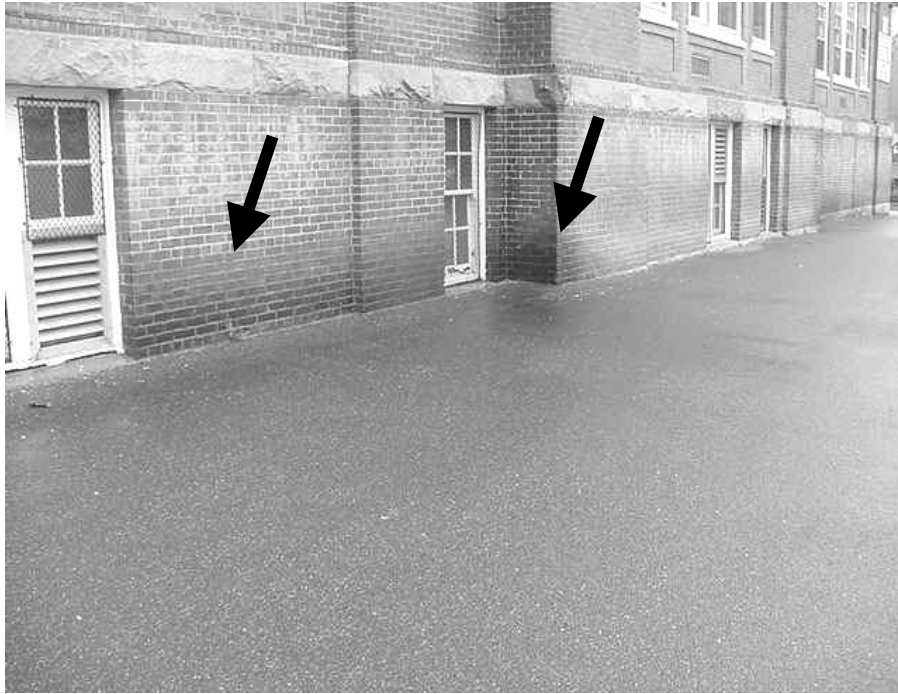
Picture 7

The HGS was evaluated during a rainstorm. The exterior wall and the tarmac joints were moistened at a height of one foot around the base of the building (see Picture 7). Some areas have moss growing at the base of the exterior wall (see Picture 8). Moss requires a significant source of moisture to exist. Moistening brick, mortar and window frames at the base of the building can lead to water penetration into basement areas, wetting building materials (e.g. GW). The wetting of exterior brick is due to the lack of gutters and downspouts (see Picture 9). The gutter and downspout system was reported by school personnel to have been removed due to the development of ice dams on the roof. Ice dams occur when snow in contact with the roof melts, forming water in the upper section of the roof, which is then refrozen on the lower portion of the roof to form ice. The source of the heat is from the roof that is incidentally heated by air escaping from the occupied spaces. The snow on the upper part of the roof melts, heated by air escaping. As water moves down sections of the roof below 32° F the water freezes forming ice and creating a dam that traps and holds water against the roof shingles. Pooling water can then penetrate through cracks and crevices in roof materials, resulting in wetting of interior building materials.

**Exterior Wall Moisture during Rain Storm, Note Height of Discoloration
(Arrow Denotes Upper Edge of Moistened Brick)**

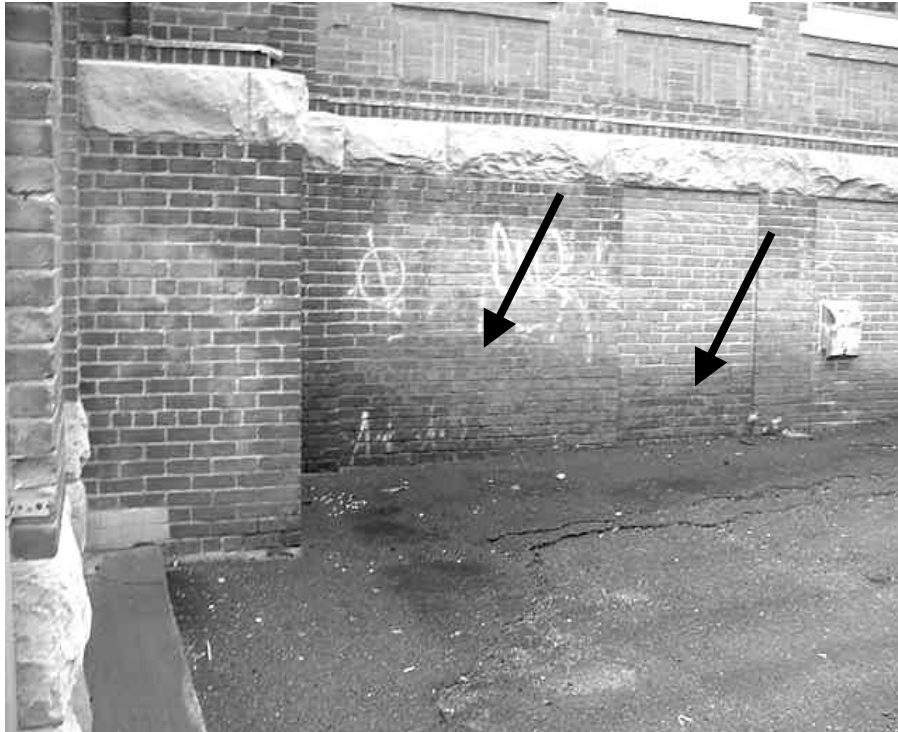
Picture 8

Moss Growth on Exterior Wall

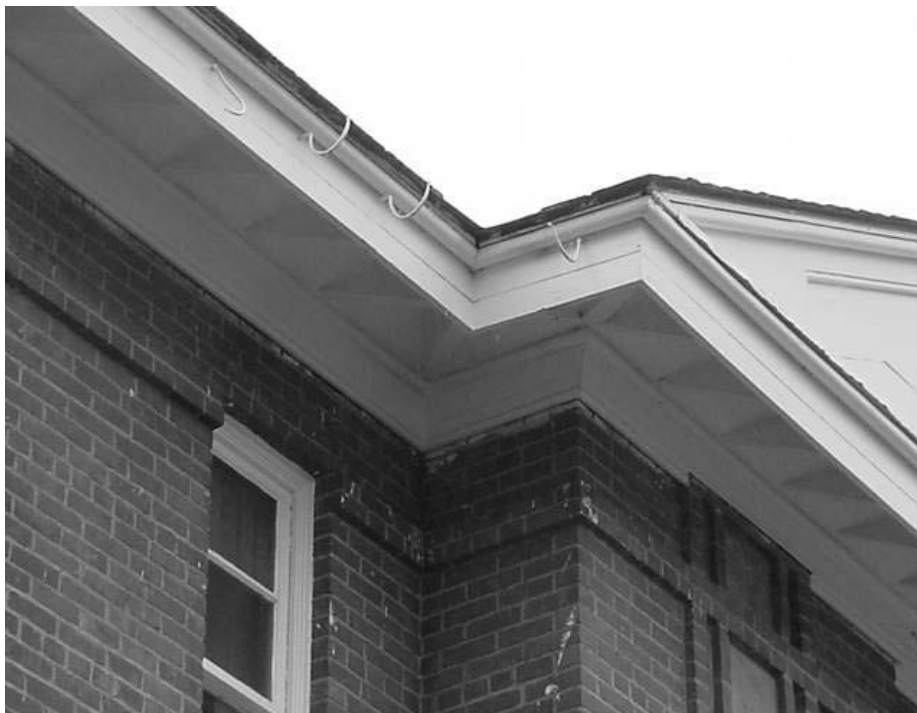
Picture 9

Racks at Roof Eave that Formally Held Gutter

1. Reinstall gutters along the eaves of all roofs.
2. Examine the feasibility of insulating the exterior of exhaust vent ductwork and motors to decrease heat transmission into the attic space.
3. Consider sealing the skylights in the attic to prevent heat transmission into the attic from solar gain.
4. Examine the feasibility of installing a passive ventilation system (e.g., soffit and ridge vents) in the attic to decrease temperature differentiation in the roof to prevent the future development of ice dams.
5. Examine the junction between the small roofs over exterior doors and the exterior wall for adequacy of flashing and pitch to prevent water penetration into adjacent window frames. If damaged, examine options for improving flashing and pitch.
6. Have a building engineer examine the cracked stone in the exterior wall of room 2 for structural integrity.

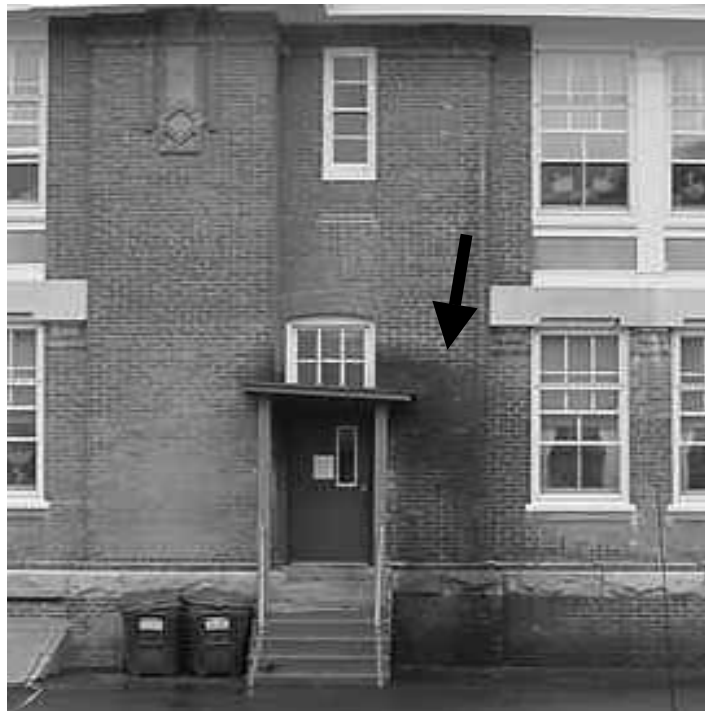
Picture 10

Other rainwater drainage conditions are also adversely affecting the building envelope. The western wall has roofs installed over exterior doors (see Picture 10). Rainwater striking these roofs can be directed toward the window frame above the roof, resulting in water penetration and subsequent damage.

Roof over Exterior Door, West Wall, Note Moisture Pattern on Exterior Brickwork

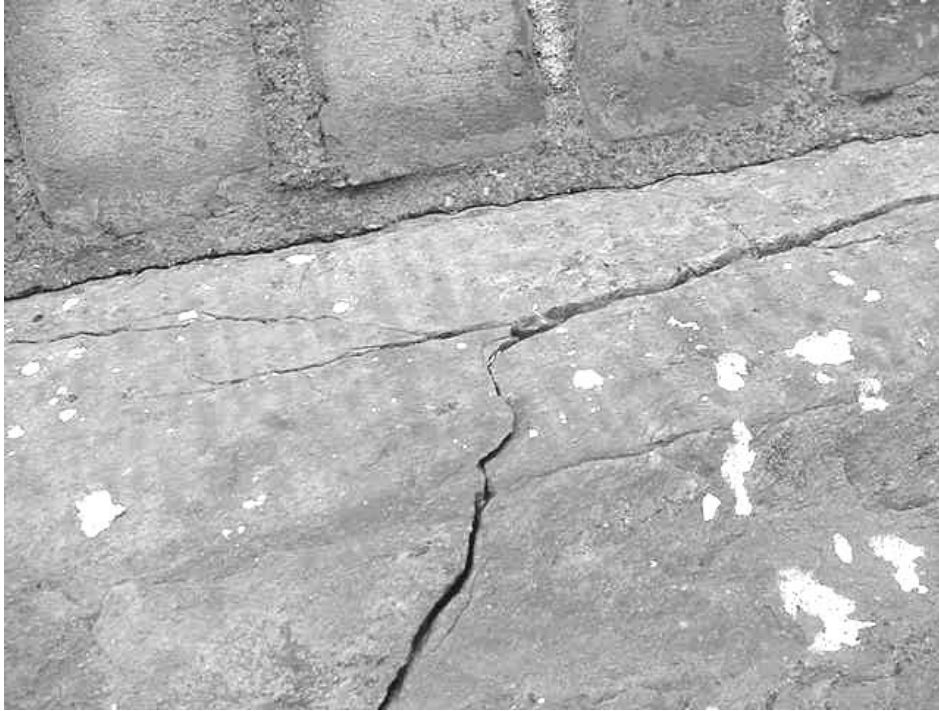
Picture 11

The window frame lintel in room 2 appears to have been replaced. An examination of the area below the window found a stone slab with a vertical crack (see Picture 11). The

existence of a vertical crack below the window may indicate some shifting in the exterior brickwork, which may create seams around the window allowing for moisture to penetrate into the interior, resulting in water damage to the window frame.

Stone Slab with Vertical Crack below Room 2 window.

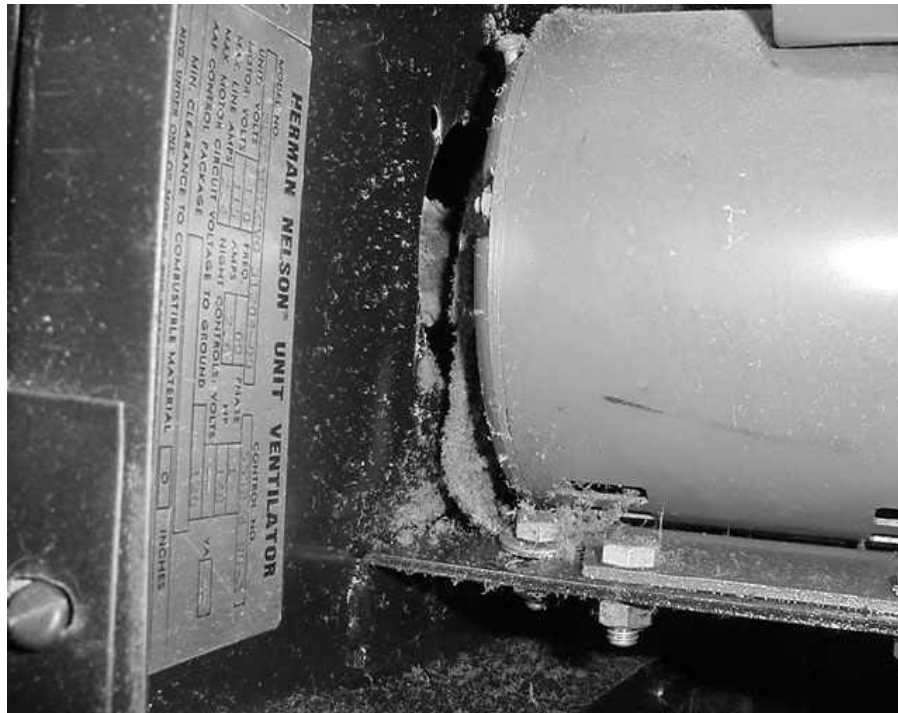
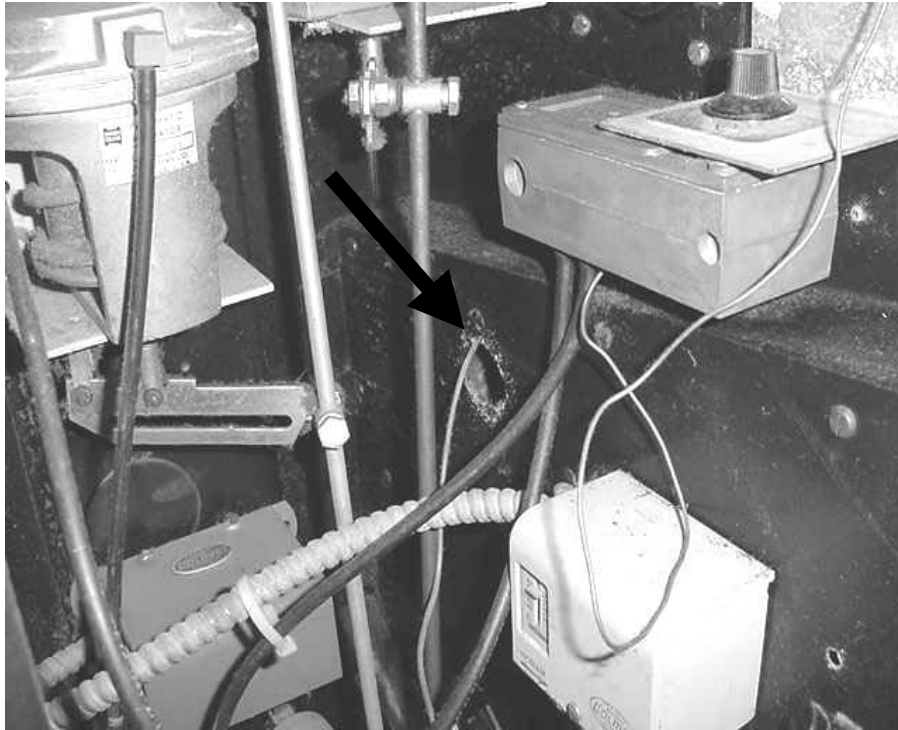
The interiors of univents in the original building were spot-checked. Walls in which univents are installed have spaces and holes within the air handling cabinet (see Pictures 12 and 13). Of note is the heavy accumulation of dust around the edges of each hole, indicating unfiltered air passage. The existence of these holes allows for air to by-pass the installed filters, resulting in aerosolization of materials (e.g. dust) from the classrooms. In addition, spaces exist around heating pipes that penetrate through the floor. Spaces of this nature can result in the univent drawing air and debris from the wall cavity or crawl space and distributing these materials to the interior of the building.

Spaces in Univent Air Handling Cavity, Note Dust Accumulation

1. Clean accumulated particulates from the air handling and control cabinets of each univent.
2. Seal all holes in the walls of the univent air handling cabinets to limit filter bypass.

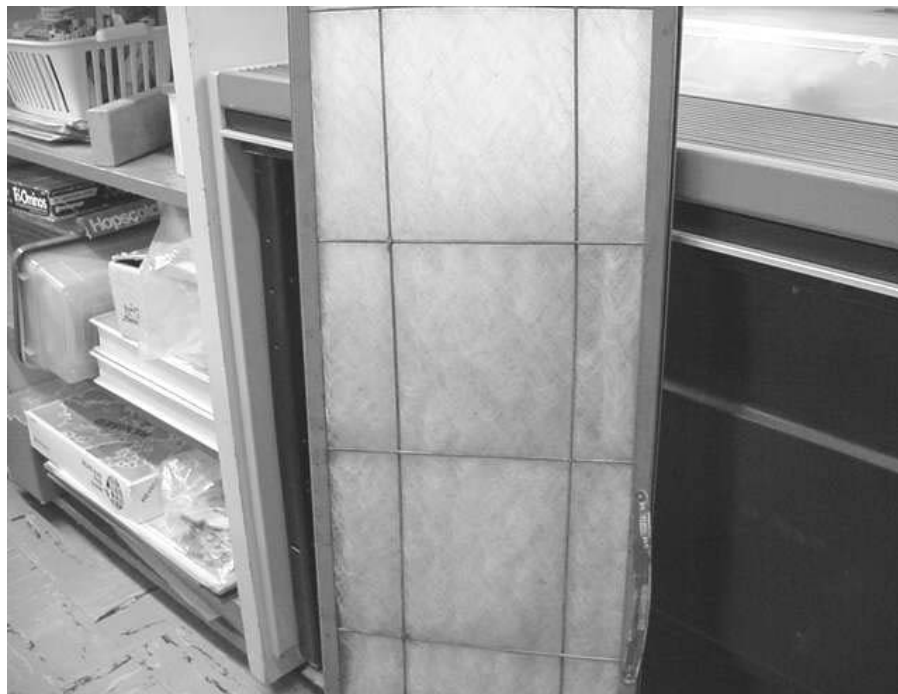
Picture 14

Univents were equipped with metal racks, into which filter materials are cut to fit (see Picture 14). The material used for filter media in these metal racks provides minimal filtration of respirable particulates that can be distributed by univents. In order to decrease aerosolized particulates, disposable filters with an increased dust spot efficiency can be installed. The dust spot efficiency is the ability of a filter to remove particulates of a certain diameter from air passing through the filter. Filters that have been determined by ASHRAE to meet its standard for a dust spot efficiency of a minimum of 40 percent (Minimum Efficiency Reporting Value equal to 9) would be sufficient to reduce many airborne

particulates (Thornburg, D., 2000; MEHRC, 1997; ASHRAE, 1992). Note that increasing filtration can reduce airflow (called pressure drop) which can reduce the efficiency of the univents due to increased resistance. Prior to any increase of filtration, each univent should be evaluated by a ventilation engineer to ascertain whether it can maintain function with more efficient filters.

Cut-to-Size Filter Medium in Metal Rack

10. Replace the metal racks with disposable filters. Consider increasing the dust-spot efficiency of HVAC filters.
11. Examine insulation in attic. Replace water damaged sections of insulation, if present.
